HISTORIC STRUCTURES VISUAL IMPACT ASSESSMENT REPORT

SOUTH CAROLINA ELECTRIC & GAS COMPANY
Cayce, South Carolina

Historic Structures Visual Impact Assessment Report
for the
Lyles-Saluda River-Lake Murray 230 kV Lines

November 2013

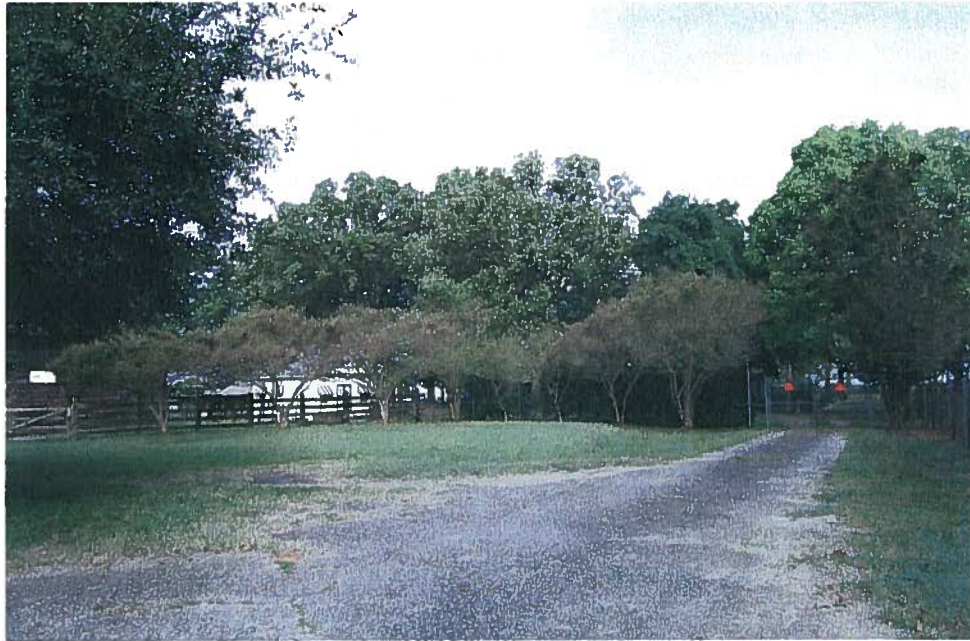
Historic Site: Resource PE 1 (243-0306)

Field Visit & Analysis: Heavy foreground screening and long distance; line route will not be visible.

Conclusion Based on the Visual Impact Assessment and Field Visit: No view

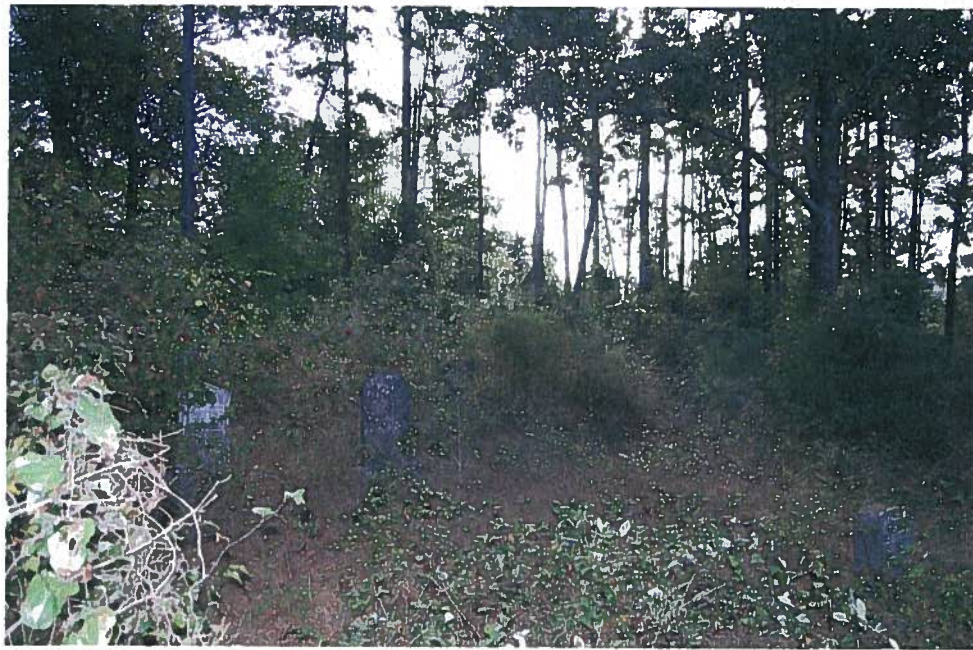
Historic Site: Resource PE 2 (243-0304) – Yninger Cemetery

Field Visit & Analysis: Heavy foreground screening; line route will not be visible.

Conclusion Based on the Visual Impact Assessment and Field Visit: No view

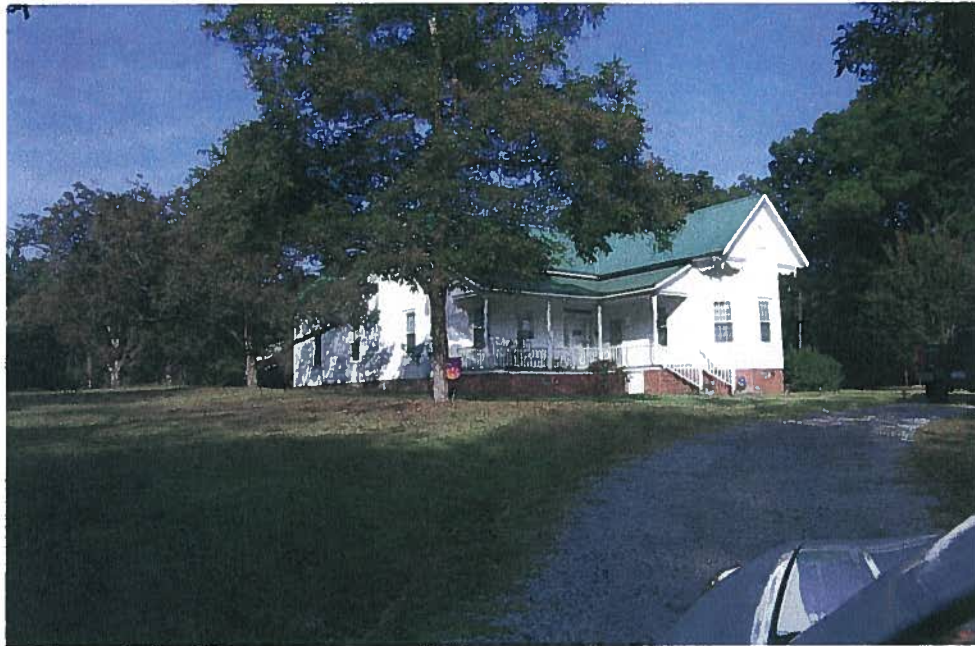
Historic Site: Resource PE 3

Field Visit & Analysis: Scattered foreground and heavy mid-ground screening; line route will not be visible.

Conclusion Based on the Visual Impact Assessment and Field Visit: No view

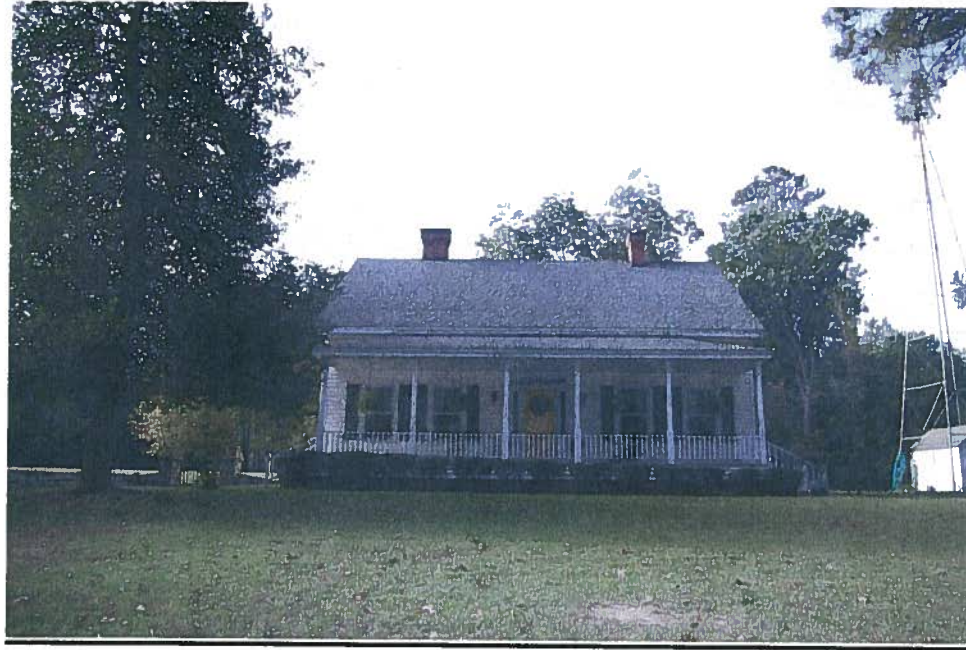
Historic Site: Resource PE 4

Field Visit & Analysis: Scattered foreground and heavy mid-ground screening; line route will not be visible.

Conclusion Based on the Visual Impact Assessment and Field Visit: No view

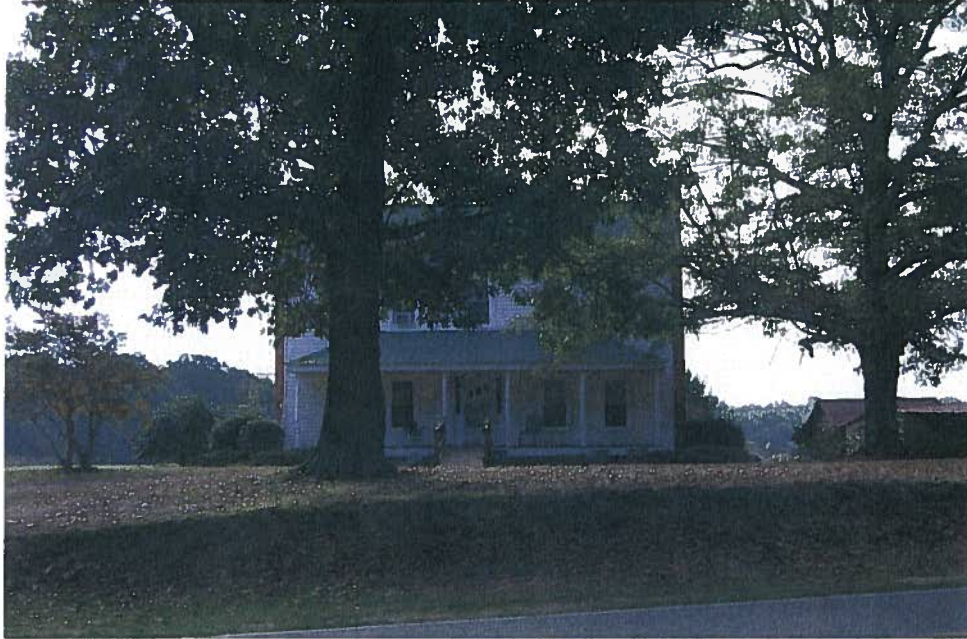
Historic Site: Resource PE 5

Field Visit & Analysis: View in the direction of the line route is currently modified by existing high-voltage transmission lines. However, heavy mid-ground screening will screen views of the proposed line route.

Conclusion Based on the Visual Impact Assessment and Field Visit: No view

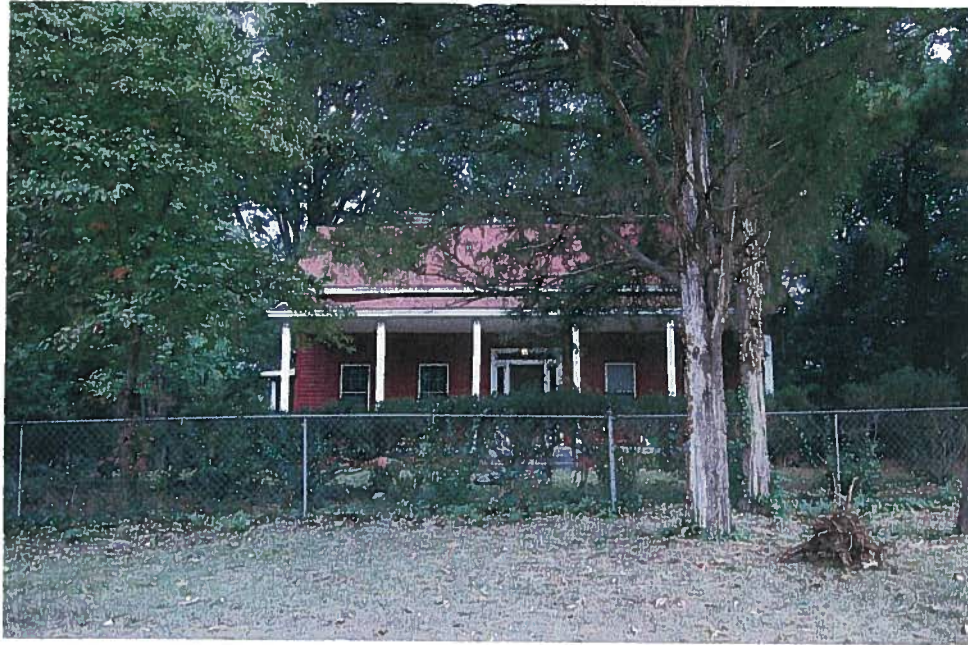
Historic Site: Resource PE 6

Field Visit & Analysis: Heavy foreground screening; line route will not be visible.

Conclusion Based on the Visual Impact Assessment and Field Visit: No view

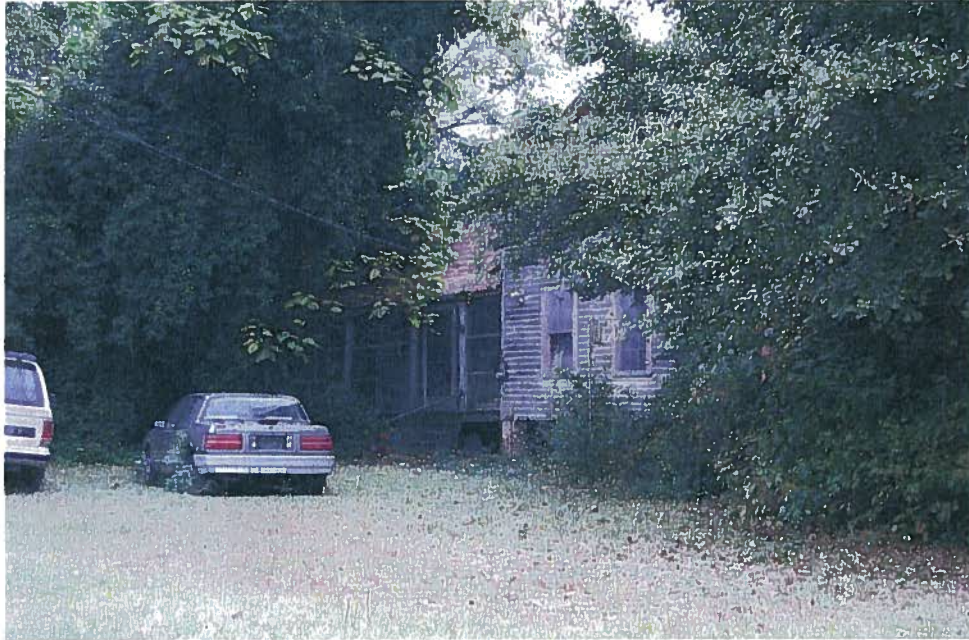
Historic Site: Resource PE 7 (SG16)

Field Visit & Analysis: Heavy foreground screening; line route will not be visible.

Conclusion Based on the Visual Impact Assessment and Field Visit: No view

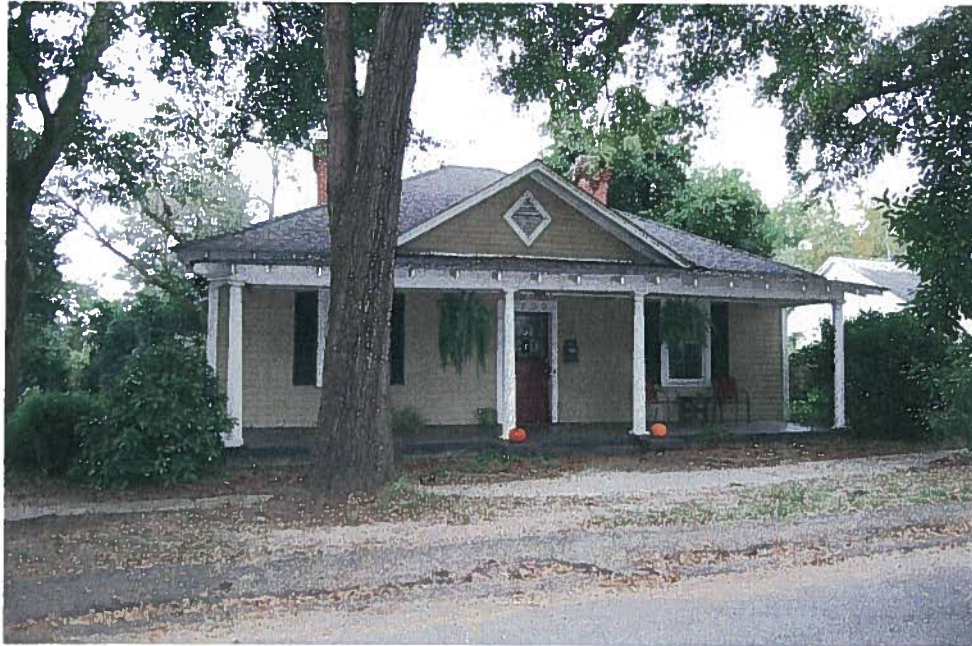
Historic Site: Resource PE 8

Field Visit & Analysis: Scattered foreground and heavy mid-ground screening coupled with topographic change; line route will not be visible.

Conclusion Based on the Visual Impact Assessment and Field Visit: No view

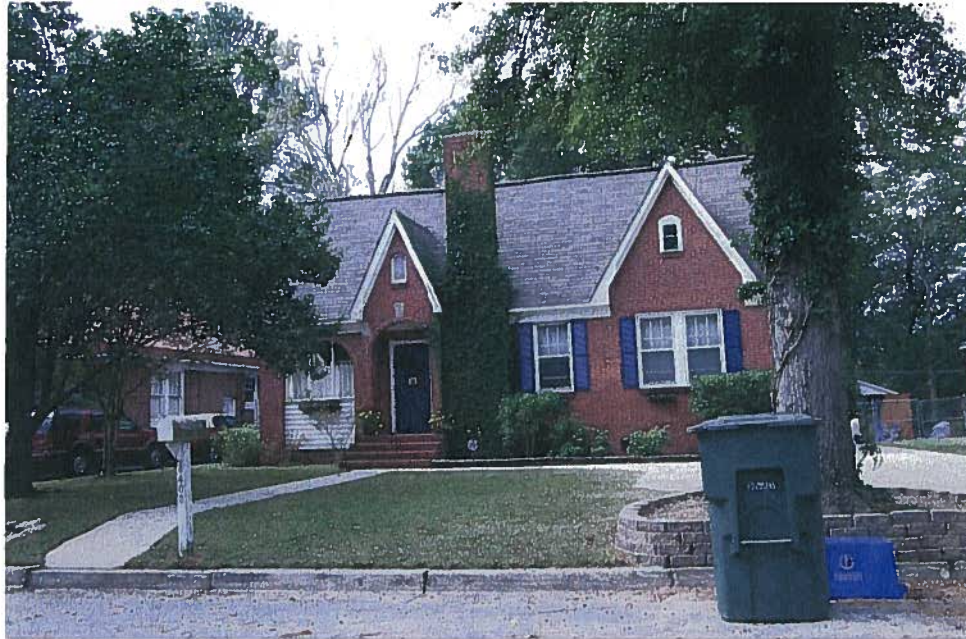
Historic Site: Resource PE 9

Field Visit & Analysis: Scattered foreground and heavy mid-ground screening coupled with topographic change; line route will not be visible.

Conclusion Based on the Visual Impact Assessment and Field Visit: No view

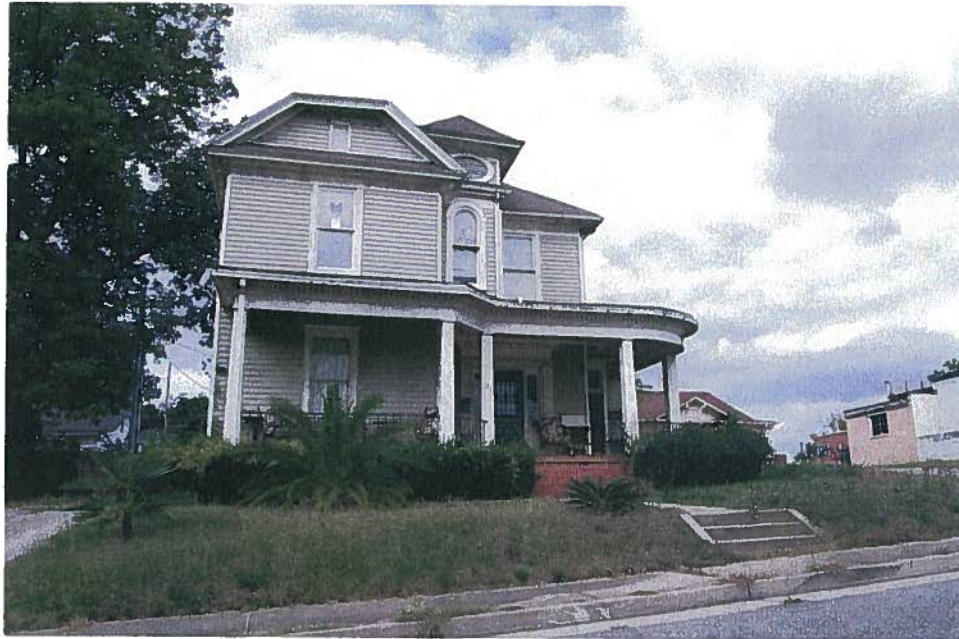
Historic Site: Resource PE 10

Field Visit & Analysis: Scattered foreground and heavy mid-ground screening coupled with topographic change; line route will not be visible.

Conclusion Based on the Visual Impact Assessment and Field Visit: No view

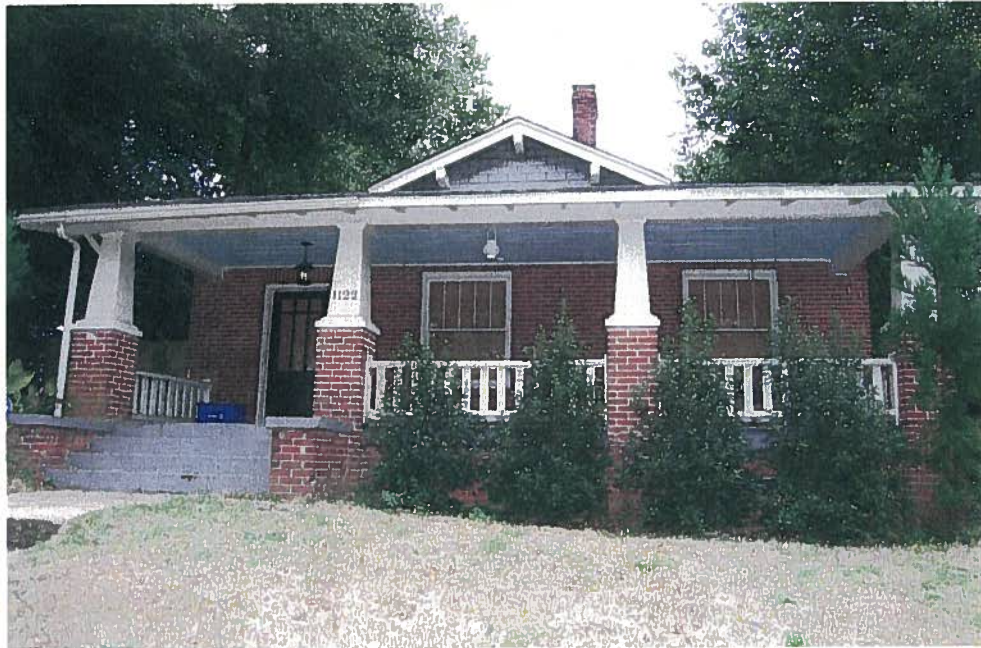
Historic Site: Resource PE 11

Field Visit & Analysis: Scattered foreground and heavy mid-ground screening coupled with topographic change; line route will not be visible.

Conclusion Based on the Visual Impact Assessment and Field Visit: No view

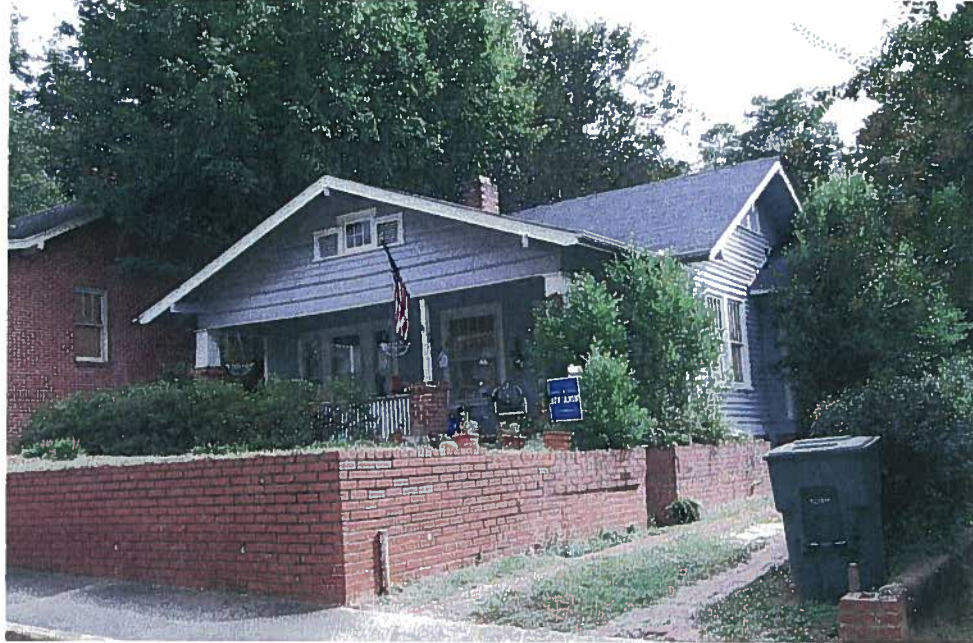
Historic Site: Resource PE 12

Field Visit & Analysis: Scattered foreground and heavy mid-ground screening coupled with topographic change; line route will not be visible.

Conclusion Based on the Visual Impact Assessment and Field Visit: No view

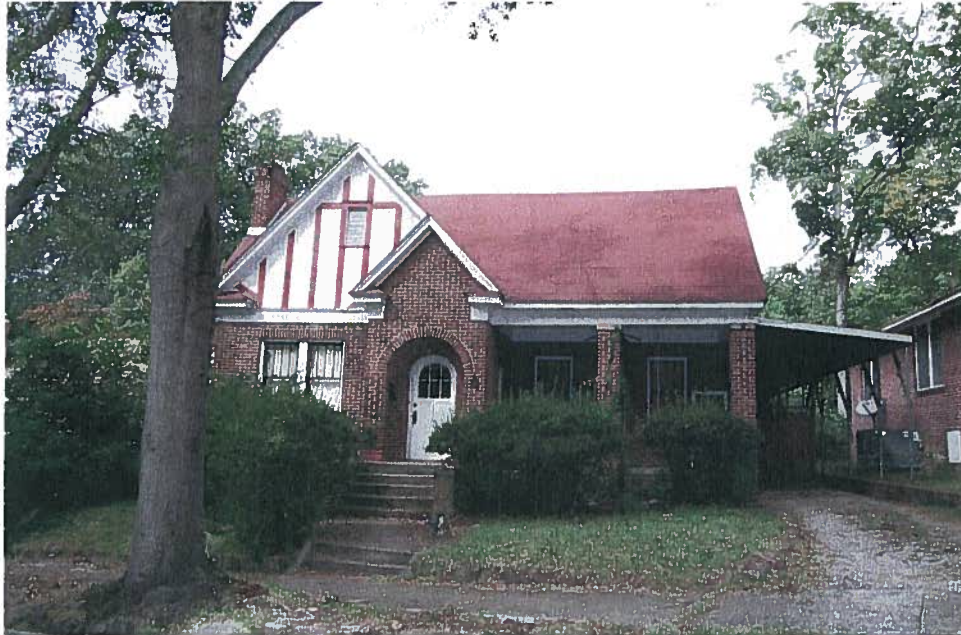
Historic Site: Resource PE 13

Field Visit & Analysis: Scattered foreground and heavy mid-ground screening coupled with topographic change; line route will not be visible.

Conclusion Based on the Visual Impact Assessment and Field Visit: No view

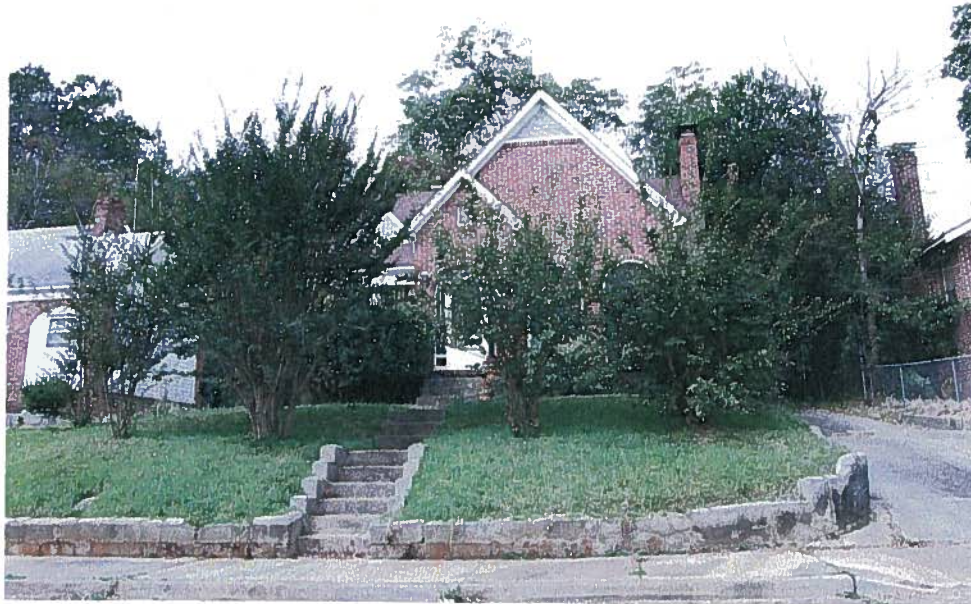
Historic Site: Resource PE 14

Field Visit & Analysis: Scattered foreground and heavy mid-ground screening coupled with topographic change; line route will not be visible.

Conclusion Based on the Visual Impact Assessment and Field Visit: No view

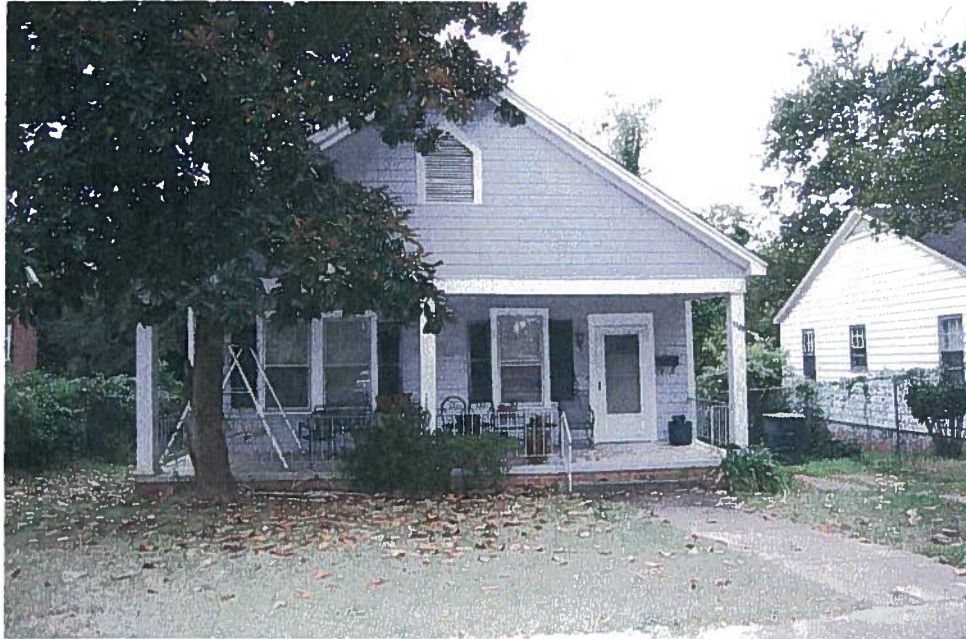
Historic Site: Resource PE 15

Field Visit & Analysis: Scattered foreground and heavy mid-ground screening coupled with topographic change; line route will not be visible.

Conclusion Based on the Visual Impact Assessment and Field Visit. No view

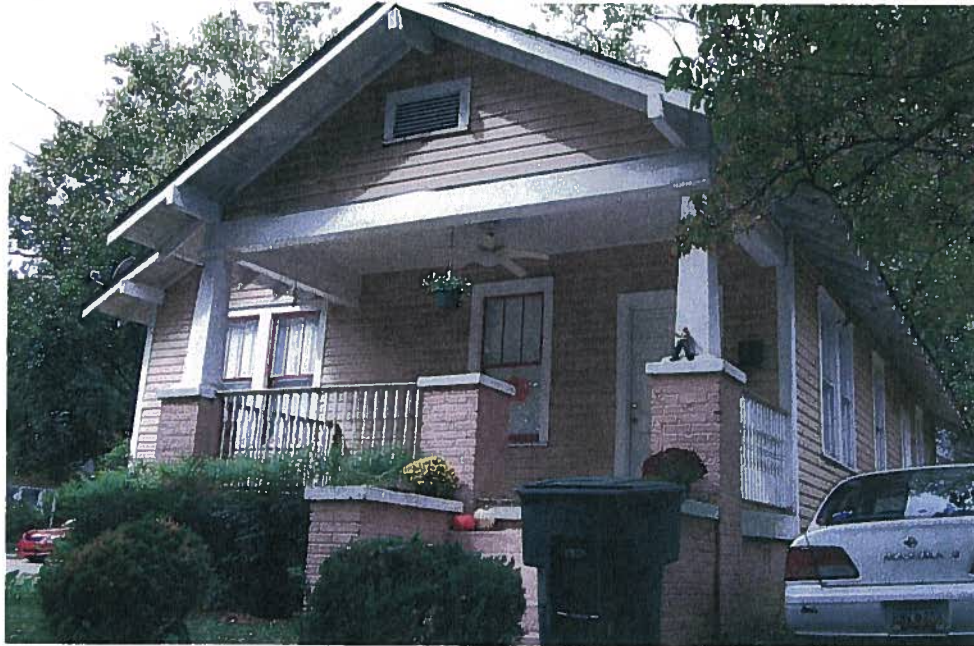
Historic Site: Resource PE 16

Field Visit & Analysis: Scattered foreground and heavy mid-ground screening coupled with topographic change; line route will not be visible.

Conclusion Based on the Visual Impact Assessment and Field Visit: No view

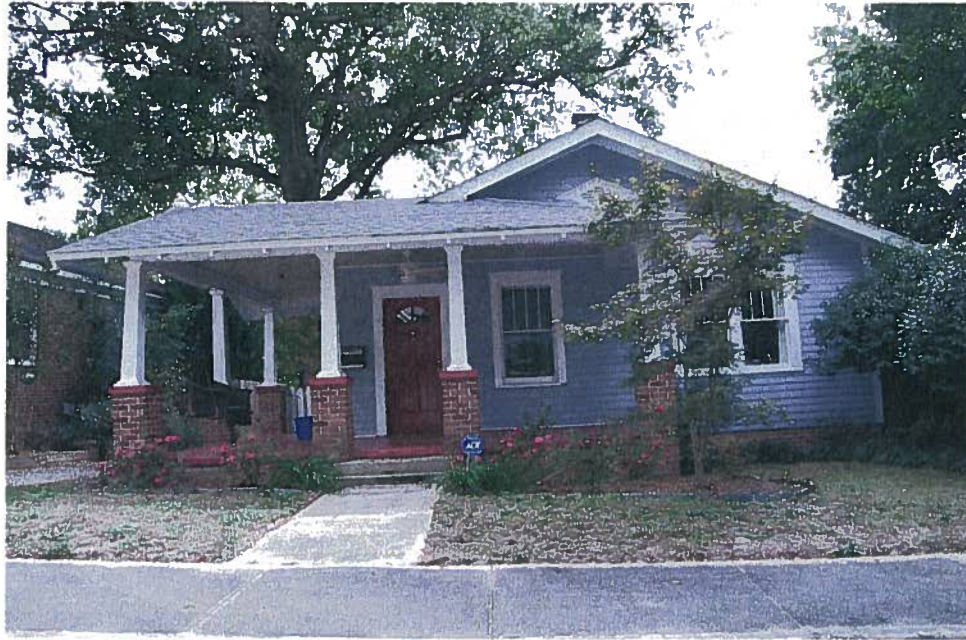
Historic Site: Resource PE 17

Field Visit & Analysis: Scattered foreground and heavy mid-ground screening coupled with topographic change; line route will not be visible.

Conclusion Based on the Visual Impact Assessment and Field Visit: No view

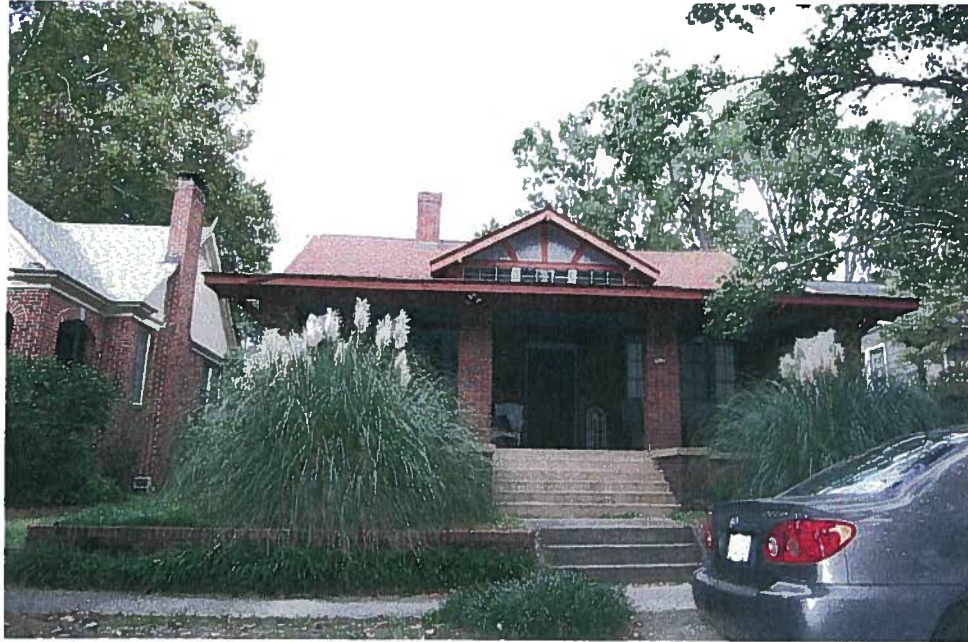
Historic Site: Resource PE 18

Field Visit & Analysis: Scattered foreground and heavy mid-ground screening coupled with topographic change; line route will not be visible.

Conclusion Based on the Visual Impact Assessment and Field Visit: No view

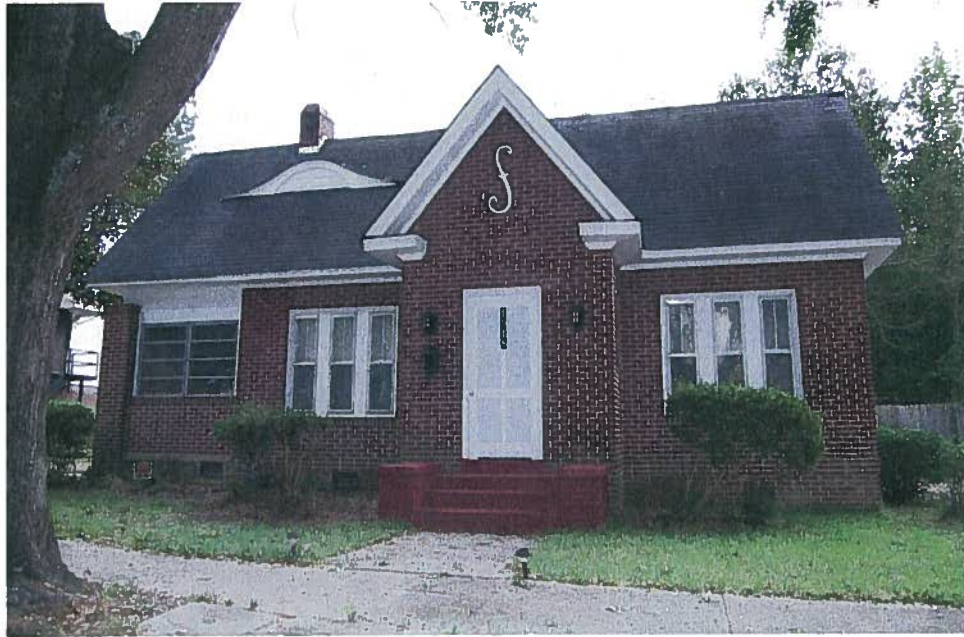
Historic Site: Resource PE 19

Field Visit & Analysis: Scattered foreground and heavy mid-ground screening coupled with topographic change; line route will not be visible.

Conclusion Based on the Visual Impact Assessment and Field Visit: No view

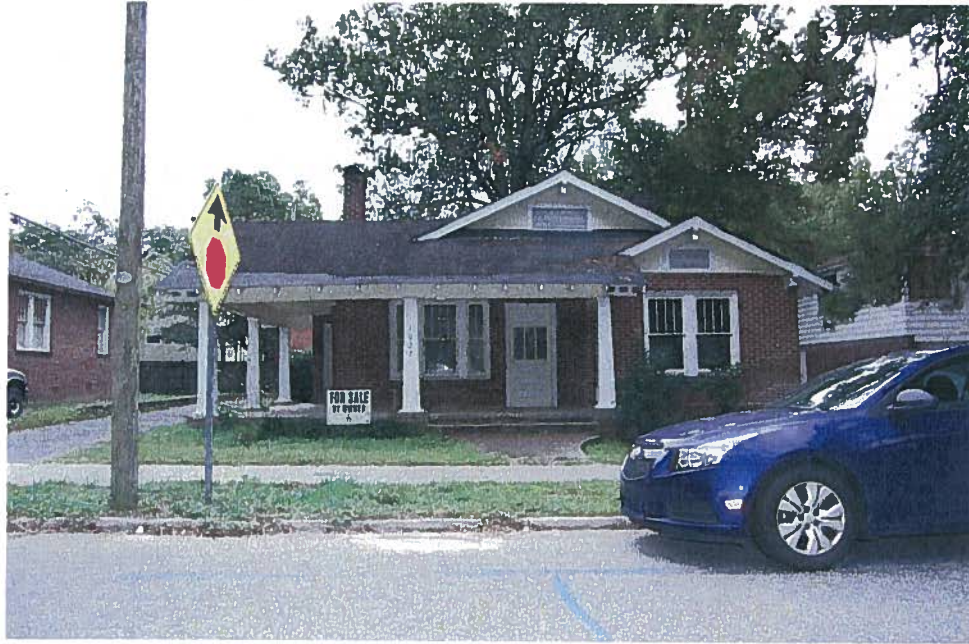
Historic Site: Resource PE 20

Field Visit & Analysis: Scattered foreground and heavy mid-ground screening coupled with topographic change; line route will not be visible.

Conclusion Based on the Visual Impact Assessment and Field Visit: No view

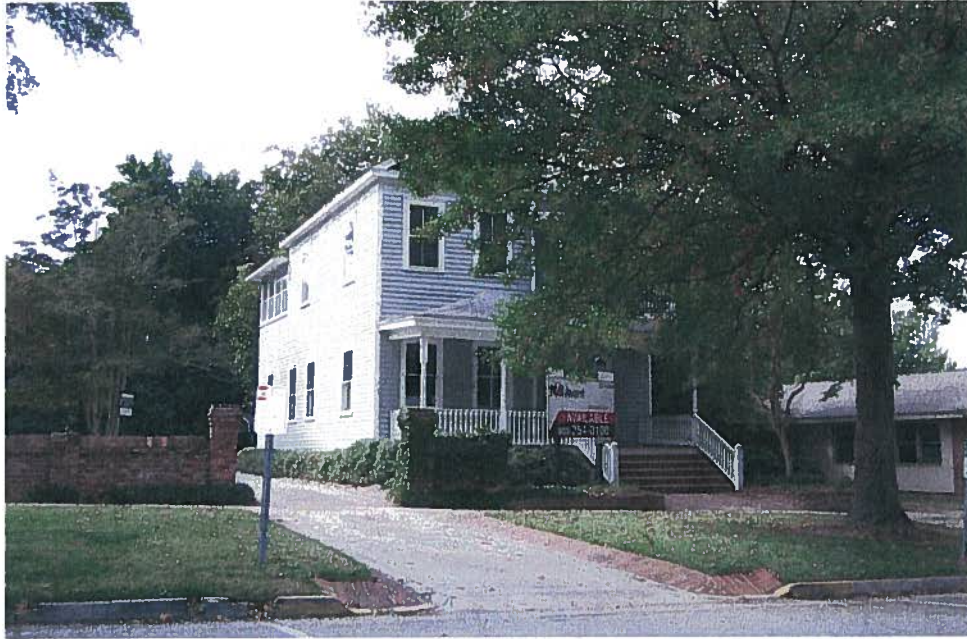
Historic Site: Resource PE 21

Field Visit & Analysis: Scattered foreground and heavy mid-ground screening; line route will not be visible.

Conclusion Based on the Visual Impact Assessment and Field Visit: No view

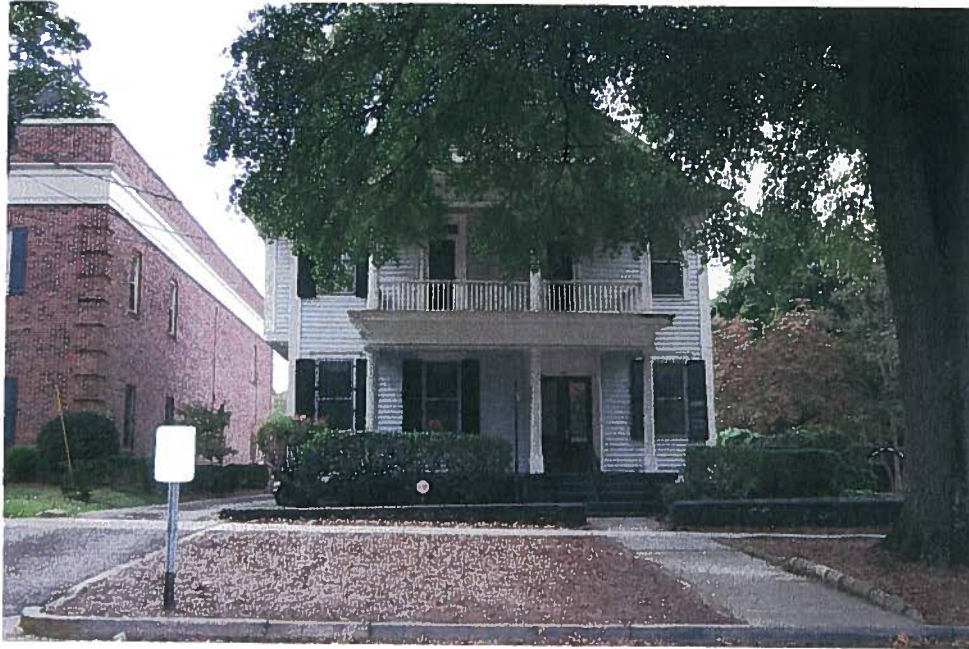
Historic Site: Resource PE 22

Field Visit & Analysis: Scattered foreground and heavy mid-ground screening; line route will not be visible.

Conclusion Based on the Visual Impact Assessment and Field Visit: No view

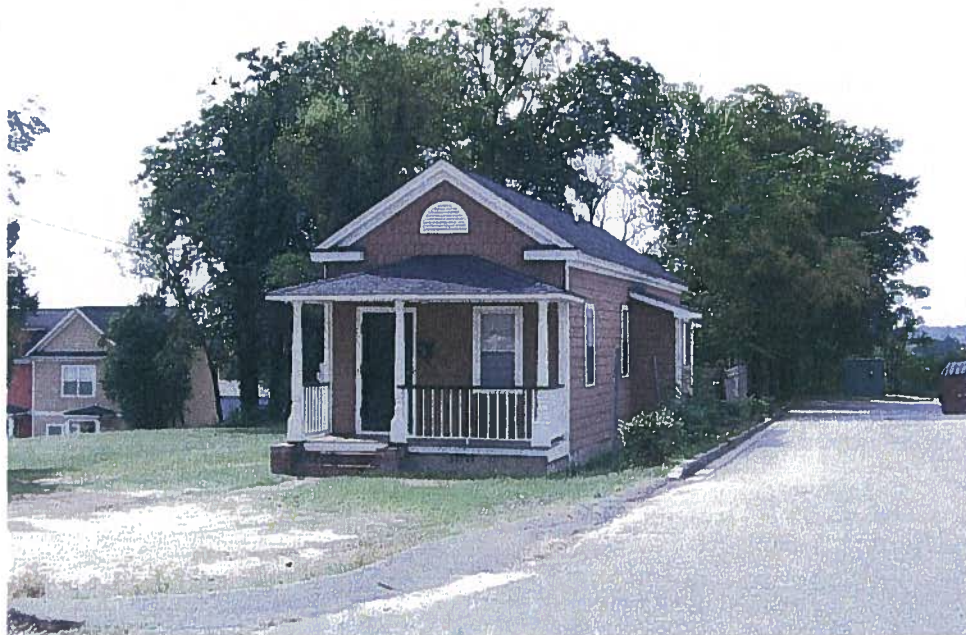
Historic Site: Resource PE 23

Field Visit & Analysis: Heavy mid-ground screening and topographic change; line route will not be visible.

Conclusion Based on the Visual Impact Assessment and Field Visit: No view
